# Manhole Inspection Summary

Manhole # S33CC1013MH

Insp Date: **3/6/07 10:16 AM**

**Location** Address: **2 UNIVERSITY PKWY**

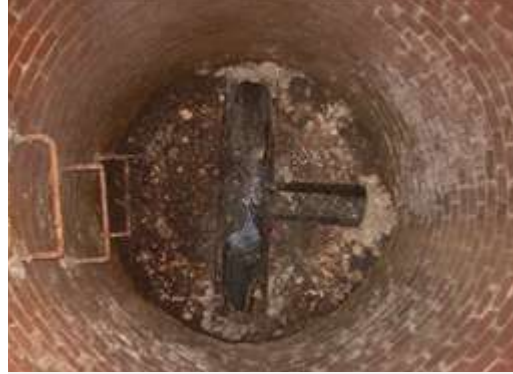
Top View

Corroded steps. Evidence of surcharge - Bench debris. Channel debris.

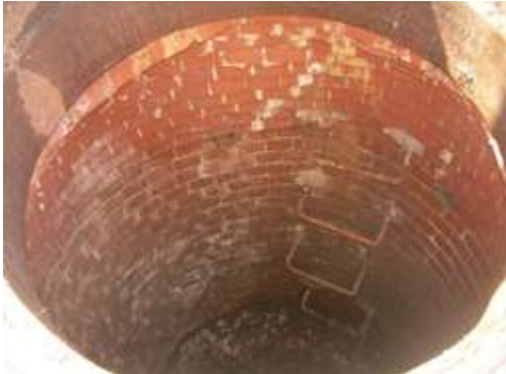
Defect

**Frame** Offset: **0** (in.) Condition: ☐ Sound ☐ Cracked ☒ **Leaks**

Infiltration: ☐ None ☒ **Joint** ☐ Cracks ☒ **Mortar** ☐ Roots ☐ Wall

Infiltration: ☐ None ☐ Joint ☐ Cracks ☐ Mortar ☐ Roots ☒ **Wall**

Infiltration: ☐ None ☐ Joint ☐ Cracks ☒ **Mortar** ☒ **Roots** ☒ **Wall**

Frame leaks. Adjustment, Corbel and Barrel infiltration.

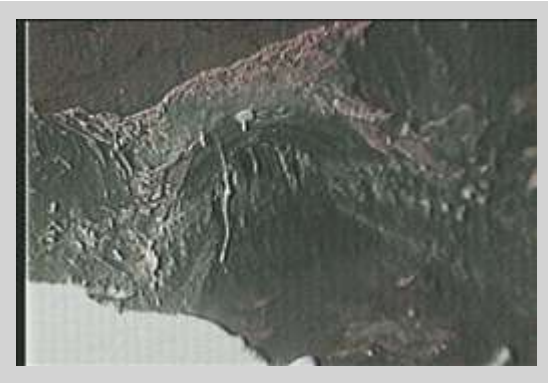
### 8 in. Circular Gravity Sewer Pipe Out @ 12 O'Clock

Channel deterioration.

Deposits: ☐ None ☒ **Mud** ☐ Sludge ☒ **Debris** ☒ **Grease**

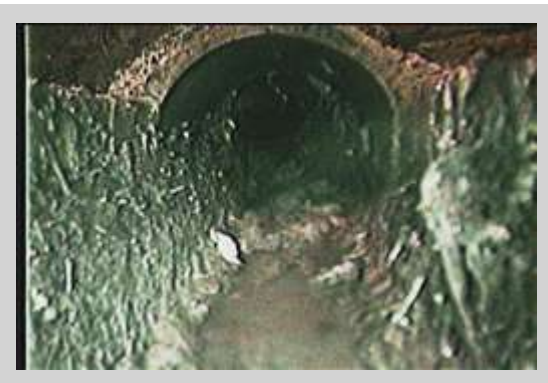
### 8 in. Circular Gravity Sewer Pipe In @ 3 O'Clock

Channel root intrusion.

Deposits: ☐ None ☒ **Mud** ☐ Sludge ☒ **Debris** ☒ **Grease**

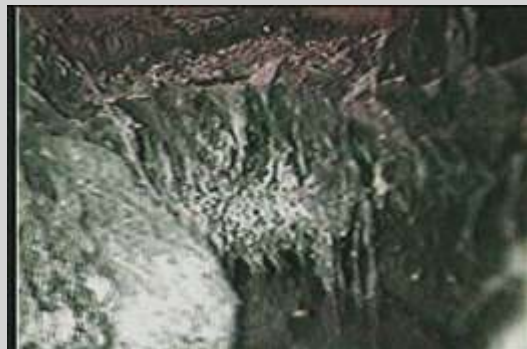
Pipe In @ 6 O'Clock

Barrel deterioration, root intrusion and infiltration.

Infiltration: **Evidence**

Pipe Seal Cond: **Roots**
